**Flood Control Project Maintenance
Levee Inspections**

Maintenance Issue Types Only, Levee Inspection Report By Mile - Spring 2019

Sacramento Maintenance Yard Sacramento Bypass

Waterway	Bank	Unit Miles	Inspection Start/End	Inspector
Unit No. 01 Sacramento Bypass or North Levee	Right	1.74	04/30/2019 04/30/2019	Zach Jojola

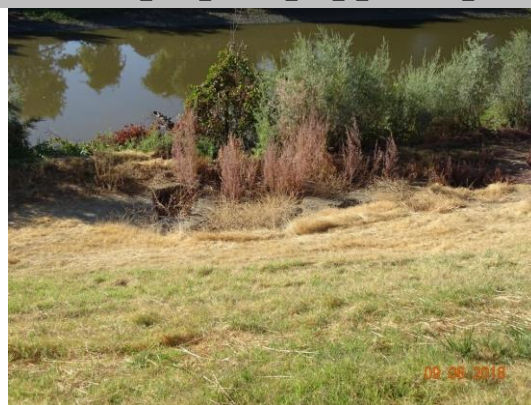
Photo 1 of 1 : SP_2019_ST0008_284_8_20190304_00002.jpg

LM Start	0.60	Rating **	A/W	Issue No.	8
LM End	0.60	Issue Type +	Ma	Location *	WS
Category	Earthen Levee			GPS Latitude/Longitude	
				Start	End
Item	Animal Control			38.603983 °	38.603983 °
				-121.570268 °	-121.570268 °
DWR ID	DWR_ST0008_01_f_2018_8				
Comment Code					
A3 : No rodents visible, but rodent burrows visible; need to backfill and compact or grout burrows.					
Inspector Comment					
Sac Yard fixed the collapsed beaver den on the waterside slope. This area should be monitored for future activity.

View of beaver den on the waterside toe road. Fall 2018.

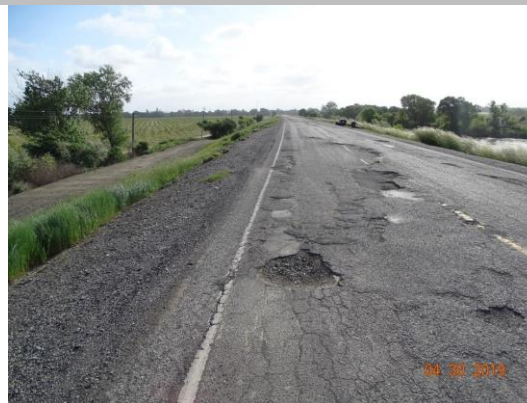
Photo 1 of 1 : SP_2019_ST0008_284_12_20190430_00014.jpg

LM Start	0.75	Rating **	A/W	Issue No.	12
LM End	0.75	Issue Type +	Ma	Location *	CR
Category	Earthen Levee			GPS Latitude/Longitude	
				Start	End
Item	Crown Surface / Depressions / Rutting			38.603337 °	38.603337 °
				-121.572912 °	-121.572912 °
DWR ID	DWR_ST0008_01_s_2019_12				
Comment Code					
C2 : Repair depressions or ruts in the crown or slope.					
Inspector Comment					
There is visible settlement on the crown on County Road 126. Recommend monitoring for further movement.

View of settlement on crown. Spring 2019.

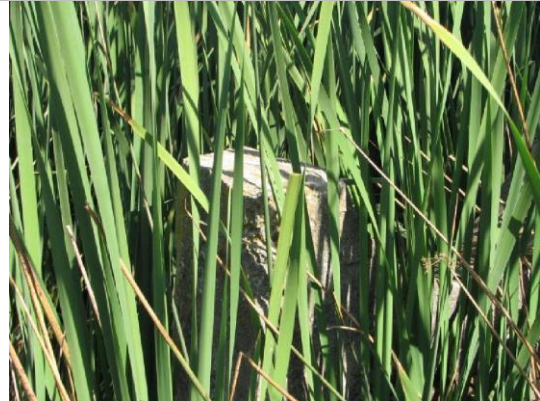
Photo 3 of 3 : UCIP_SP_2019_44787_20606.jpg

LM Start	1.09	Rating **	A/W	Issue No.	18 (cont)
LM End	1.09	Issue Type +	Ma	Location *	
Category	Supplemental			GPS Latitude/Longitude	
				Start	End
Item	DWR UCIP LMA Responsibility			38.602169 °	38.602169 °
				-121.579000 °	-121.579000 °
DWR ID	19076				
Comment Code					
Inspector Comment					
FS_ID:44787 DS_ID:19076 EP_NO: N/A Repair Type: No Action Needed Crossing Status: Found UCIP Comments: A concrete saddle found on slough/drainage. No pump was found on LS and no structure/pipe found on WS. FIELD_STRUCT_DESC: *ABANDONED* 36-inch corrugated metal drainage pipe through the levee, at an unknown depth. Grouted in place. Remains of concrete structure found on the landside (LS). [Additional Reference(s): USACE Sacramento O&M Manual 122.1, August 1955, (RM 174)]. FS Date: 4/28/2015 2:44:05 PM

Landside view: remaining of concrete structure on drainage/slough

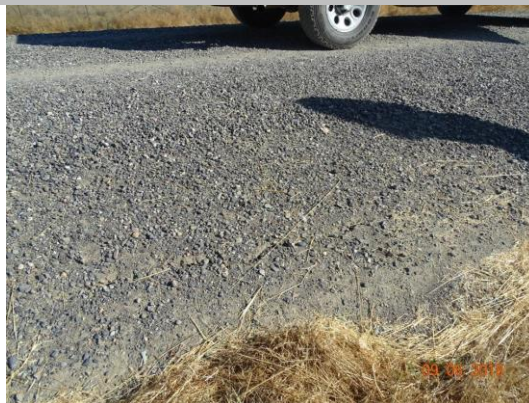
Photo 1 of 1 : SP_2019_ST0008_284_7_20190304_00001.jpg

LM Start	1.43	Rating **	A/W	Issue No.	7
LM End	1.59	Issue Type +	Ma	Location *	WS
Category	Supplemental			GPS Latitude/Longitude	
				Start	End
Item	2017 USACE Erosion Survey, DRAFT			38.600456 °	38.599713 °
				-121.584883 °	-121.587668 °
DWR ID	DWR_ST0008_01_f_2018_7				
Comment Code					
Inspector Comment					
2017 Site ID: SAP 1.4 R Status: Critical 2017 Field Notes: New site, immediately upgraded to critical. Start of slump failure, deep cracks along levee crest, concern that a large slump failure will occur from the next heavy rain. Site History: DWR Inspector Comment: Did not observe significant damage on the waterside slope. Minor craking on the crown. Recommend monitoring.

View of the cracking on the crown. Fall 2018.

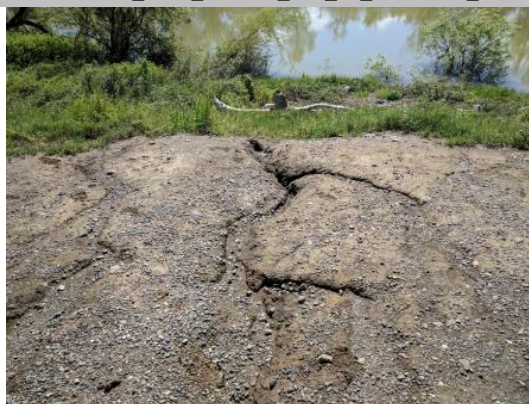
Photo 1 of 1 : SP_2019_ST0008_284_15_20190304_00004.jpg

LM Start	1.74	Rating **	A/W	Issue No.	15
LM End	1.74	Issue Type +	Ma	Location *	WS
Category	Earthen Levee			GPS Latitude/Longitude	
				Start	End
Item	Erosion / Bank Caving			38.599546 °	38.599546 °
				-121.590235 °	-121.590235 °
DWR ID	DWR_ST0008_01_s_2018_15				
Comment Code					
E1 : Note and monitor erosion site.					
Inspector Comment					
There is runoff erosion on the oversized levee section located on the waterside levee slope. Recommend monitoring.

View of erosion on waterside slope. Spring 2017.

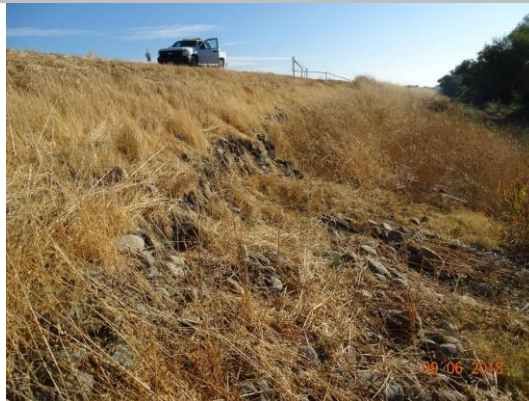
Photo 1 of 4 : SP_2019_ST0008_285_1_20190304_00001.jpg

LM Start	1.26	Rating **	A/W	Issue No.	1
LM End	1.79	Issue Type +	Ma	Location *	
Category	Supplemental			GPS Latitude/Longitude	
				Start	End
Item	2017 Storm Damage			38.597023 °	38.594527 °
				-121.577558 °	-121.586638 °
DWR ID	DWR_ST0008_02_f_2017_1				
Comment Code					
Inspector Comment					
Levee Evaluation Comments					
Description:					
Site ID No:260					
Site Designation:LMA-55					
Repair Type: Erosion					
Rating:Area of Concern					
Field Date:6/5/2017					
Notes: Minor wavewash on landside levee slope; no active erosion; no cross section taken, photo only. The erosion is not within the prism. Sac Yard will fix after vegetation gets burned. Fall 2018.

View of the worst section of erosion, just past the gate near the end of the unit. Fall 2018.

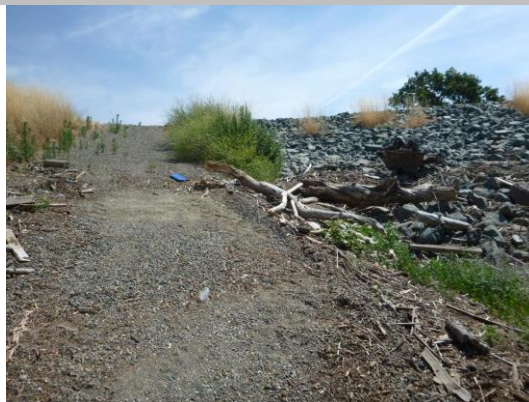
Photo 2 of 4 : LEVAL_SP_2019_260_471.jpg

Photo from storm site evaluations.

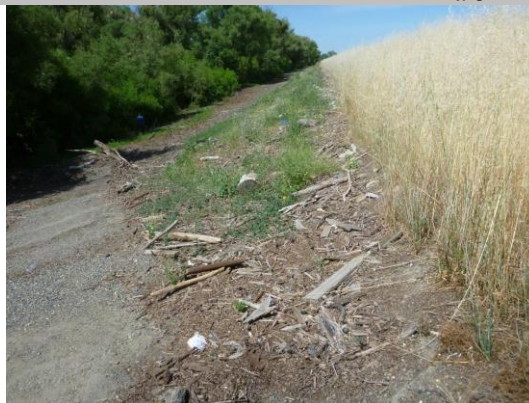
Photo 3 of 4 : LEVAL_SP_2019_260_473.jpg

LM Start	1.26	Rating **	A/W	Issue No.	1 (cont)	
LM End	1.79	Issue Type +	Ma	Location *		
Category	Supplemental			GPS Latitude/Longitude		
				Start	End	
Item	2017 Storm Damage			38.597023 °	38.594527 °	
				-121.577558 °	-121.586638 °	
DWR ID	DWR_ST0008_02_f_2017_1					
Comment Code						
Inspector Comment						
Levee Evaluation Comments						
Description:						
Site ID No:260						
Site Designation:LMA-55						
Repair Type: Erosion						
Rating:Area of Concern						
Field Date:6/5/2017						
Notes: Minor wavewash on landside levee slope; no active erosion; no cross section taken, photo only. The erosion is not within the prism. Sac Yard will fix after vegetation gets burned. Fall 2018.

Photo from storm site evaluations.

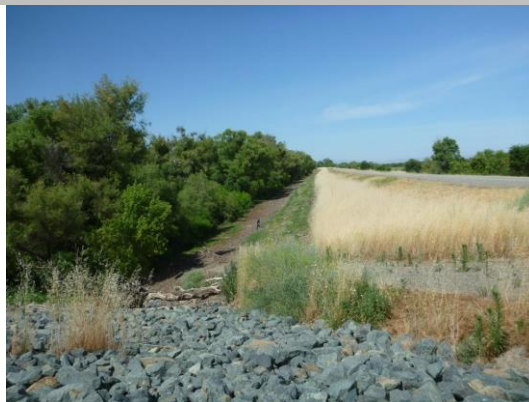
Photo 4 of 4 : LEVAL_SP_2019_260_475.jpg

Photo from storm site evaluations.

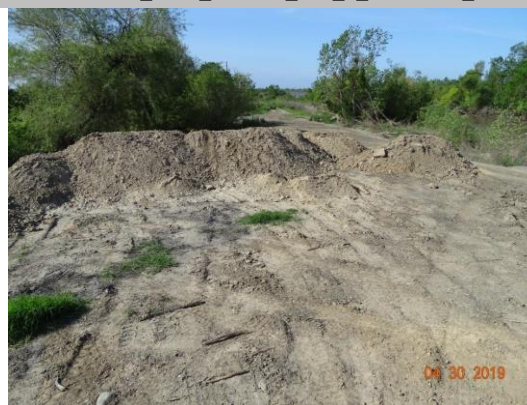
Photo 1 of 1 : SP_2019_ST0008_285_7_20190430_00010.jpg

LM Start	1.77	Rating **	M	Issue No.	7
LM End	1.77	Issue Type +	Ma	Location *	CR
Category	Earthen Levee			GPS Latitude/Longitude	
				Start	End
Item	Encroachments			38.594752 °	38.594752 °
				-121.586558 °	-121.586558 °
DWR ID	DWR_ST0008_02_s_2019_7				
Comment Code					
MA : Material					
Inspector Comment					
It appears that dirt was placed on the crown to block vehicle access at the end of the unit.

View of material on the crown. Spring 2019.
